DOT/FAA/TC-17/63

Round Robin Evaluation of CACRC Bonded Repairs

November 2017

Final Report

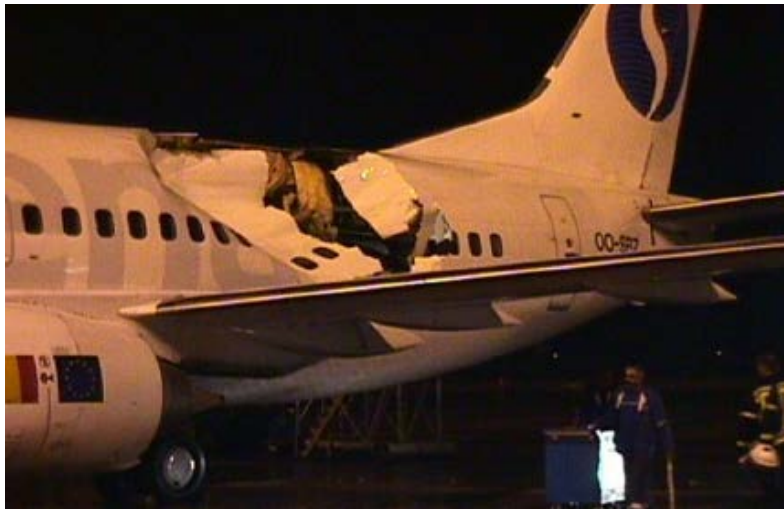
Figure 1. In-service damage [2]

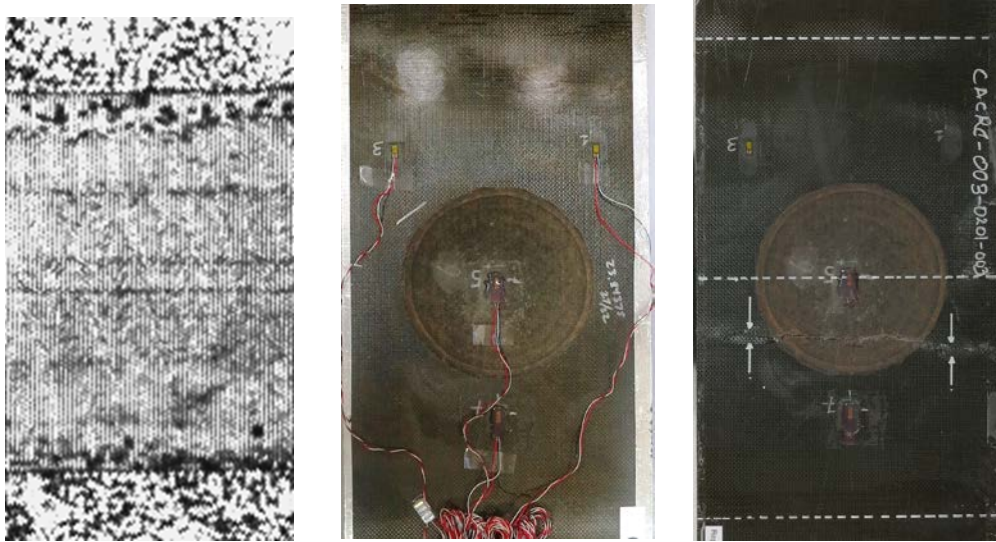
Figure 47. CACRC-003-0201-003-P-RC-ETW (element 9), TTU scan, pre- and post-test picture (understrength repair)

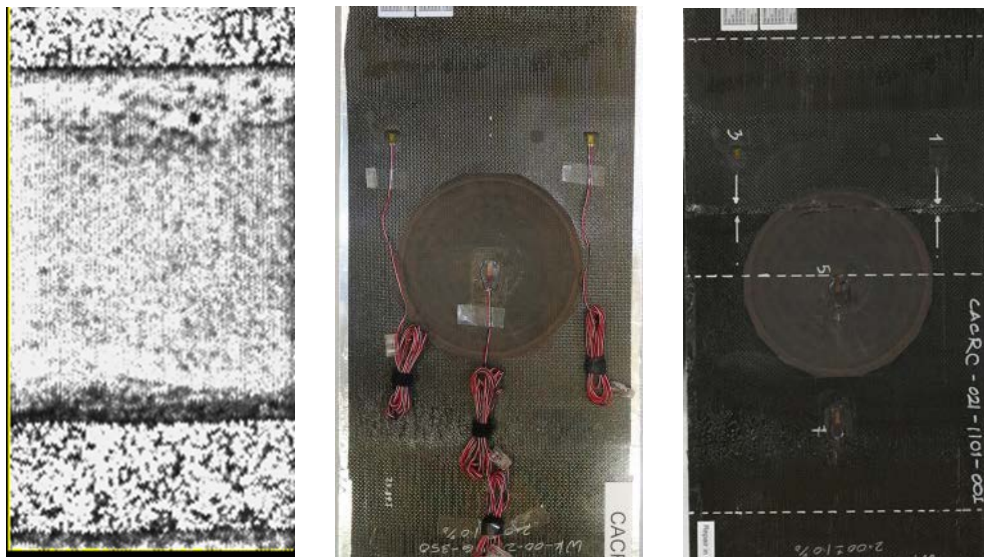
Figure 48. CACRC-021-1101-001-P-RC-ETW (element 10), TTU scan, pre- and post-test picture (understrength repair)

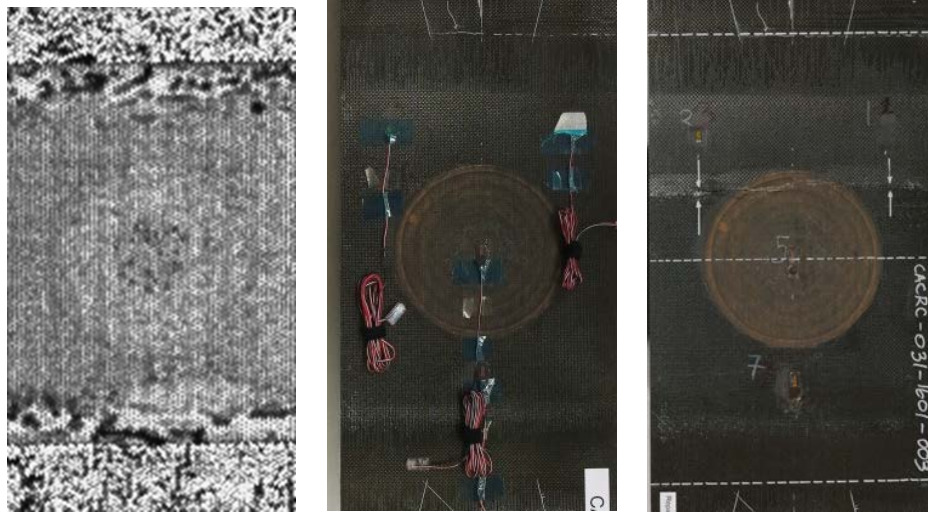
Figure 49. CACRC-031-1601-003-P-RC-ETW (element 11), TTU scan, pre- and post-test picture (understrength repair)

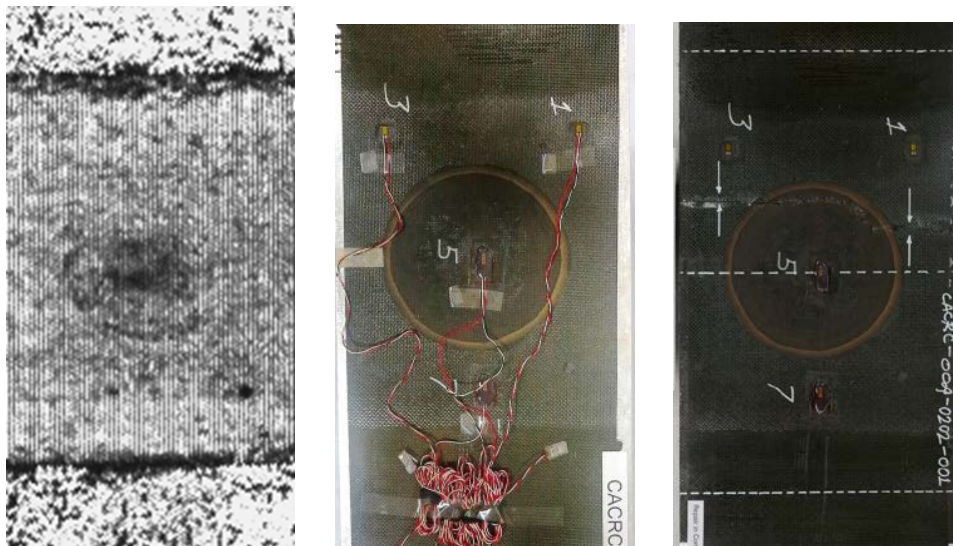
Figure 50. CACRC-004-0202-001-P-RC-ETW (element 16), TTU scan, pre- and post-test picture (understrength repair)

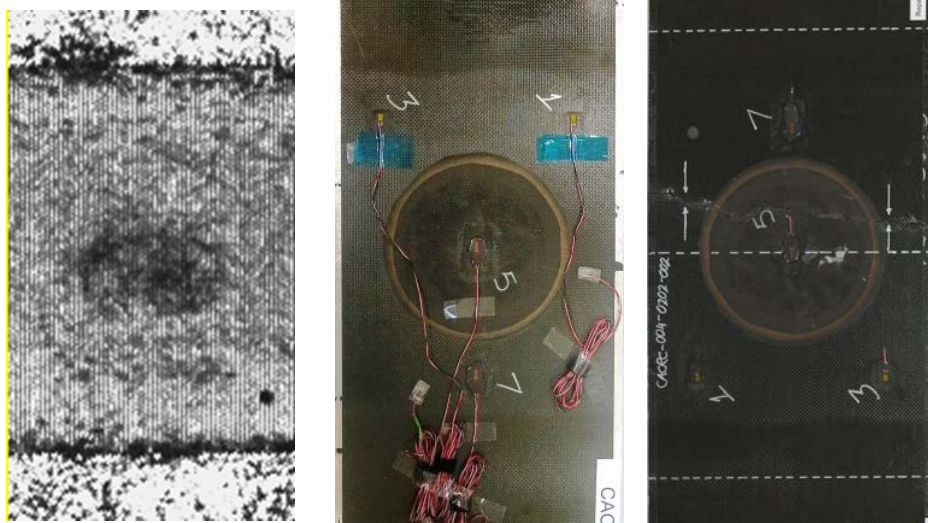
Figure 51. CACRC-004-0202-002-P-RC-ETW (Panel 17), TTU scan, pre- and post-test picture (understrength repair)

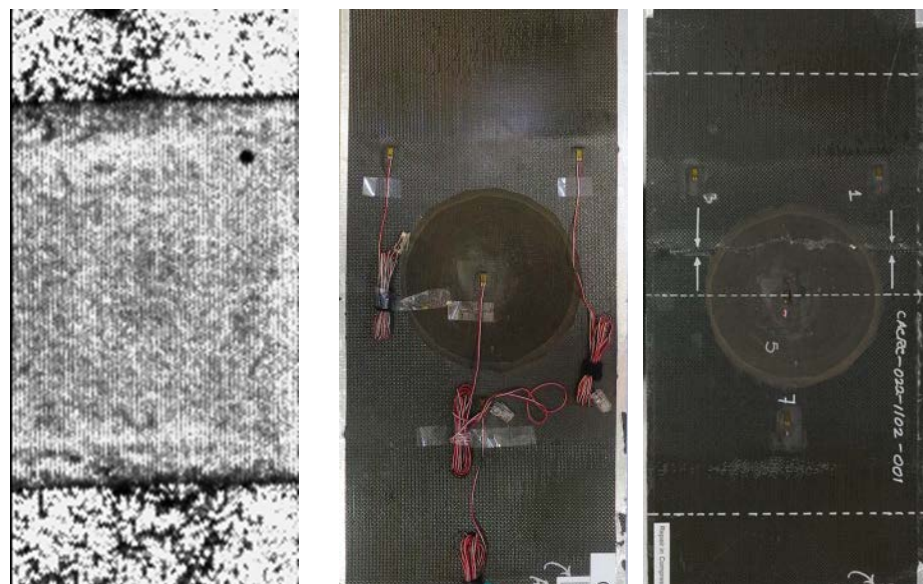
Figure 52. CACRC-022-1102-001-P-RC-ETW (Panel 18), TTU scan, pre- and post-test picture (understrength repair)

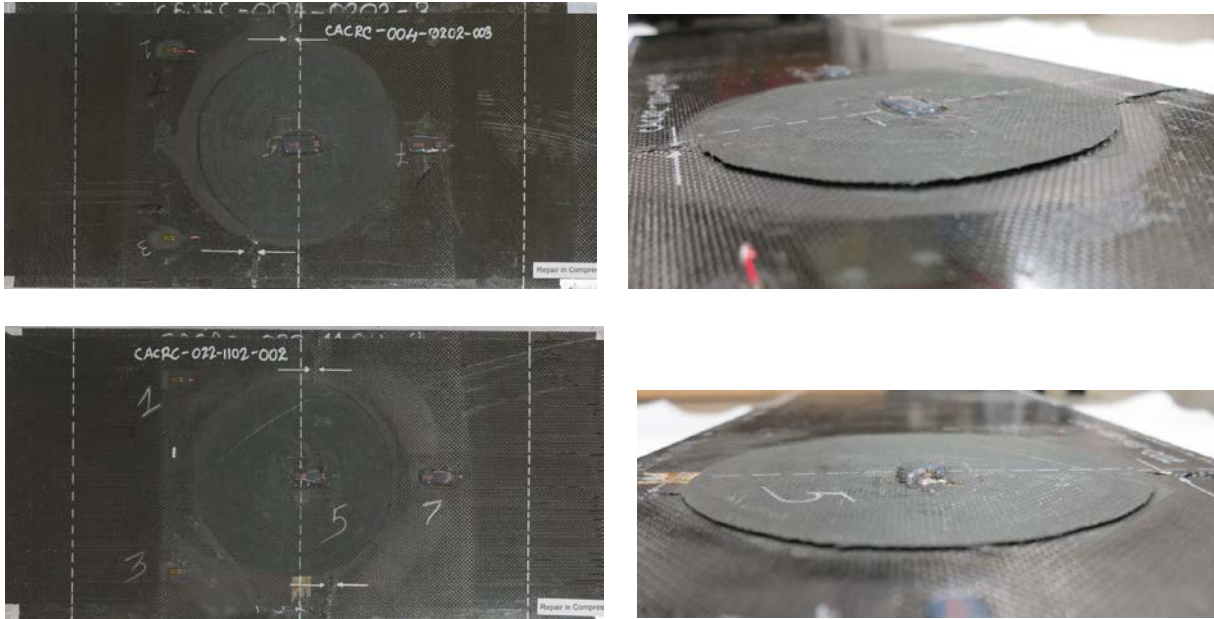
Figure 64. Representative failure modes of CACRC-R2 wet lay-up repairs using G904 D1070 TCT fabric with Epocast 52A/B (adhesion failures)

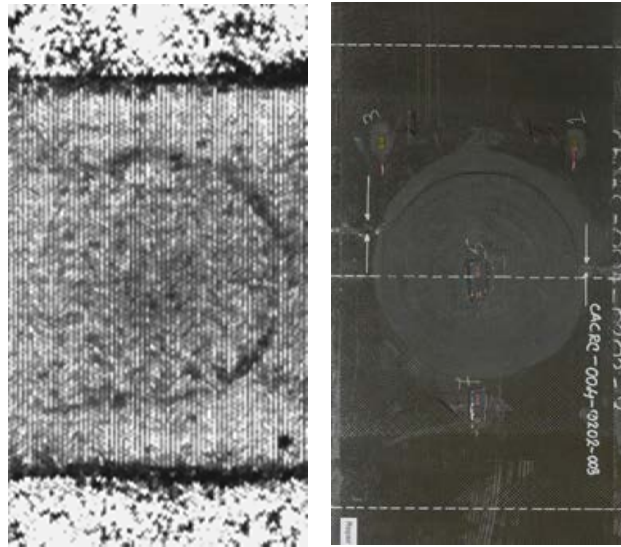
Figure 68. CACRC-004-0202-003-W-RC-ETW (element 21), TTU scan, pre- and post-test picture (adhesion failure)

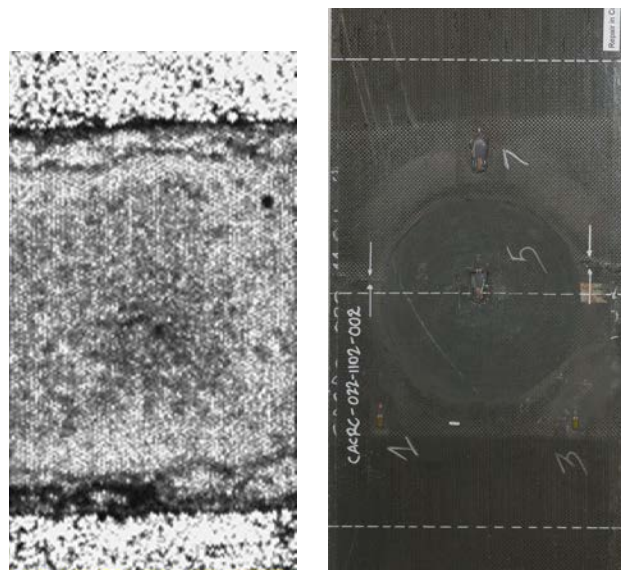
Figure 69. CACRC-022-1102-002-W-RC-ETW (element 23), TTU scan, pre- and post-test picture (adhesion failure)

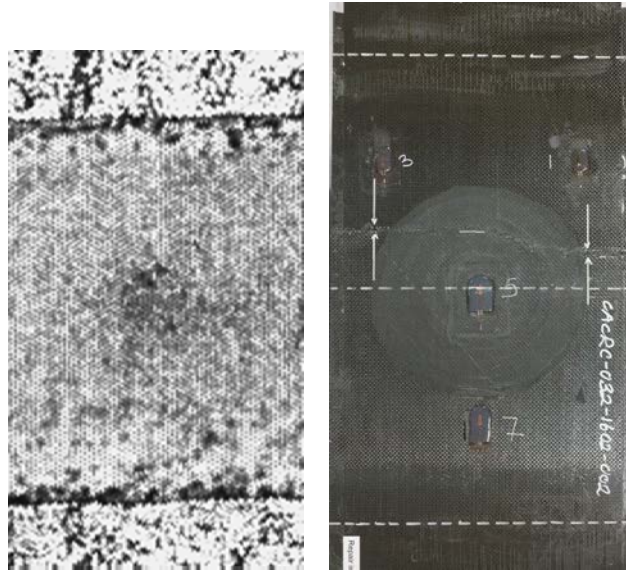
Figure 70. CACRC-032-1602-002-W-RC-ETW (element 32), TTU scan, pre- and post-test picture (understrength repair, facesheet compression failure through repair)

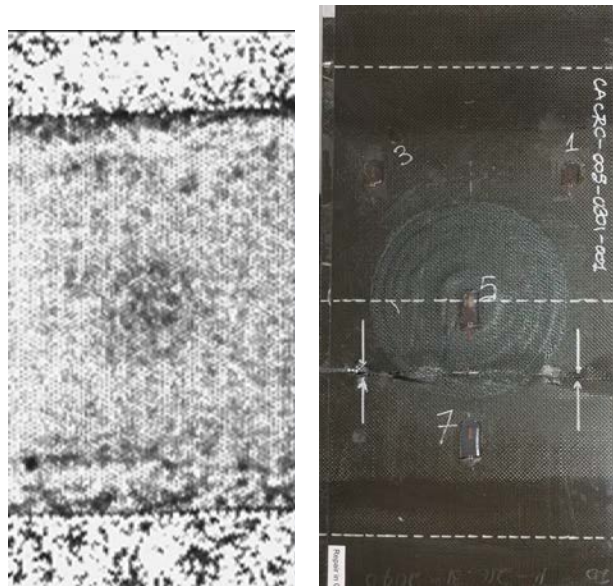
Figure 71. CACRC-005-0301-001-W-RC-ETW (element 10), TTU scan, pre- and post-test picture (facesheet compression failure through the repair)

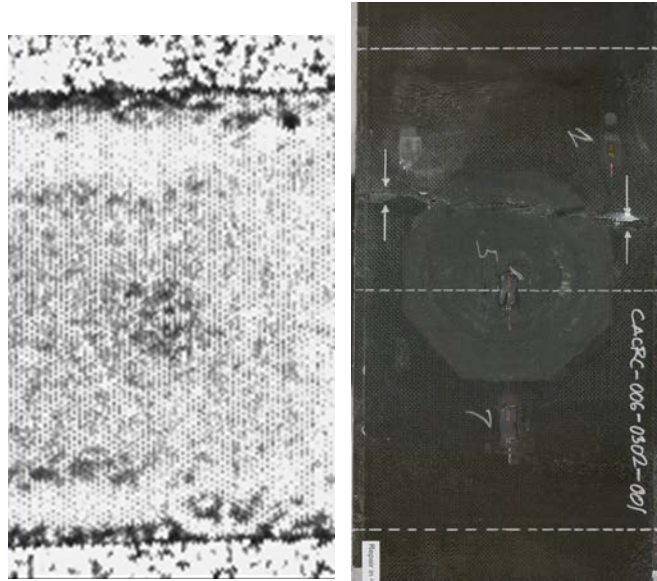
Figure 72. CACRC-006-0302-001-W-RC-ETW (element 24), TTU scan, pre- and post-test picture (facesheet compression failure through the repair)

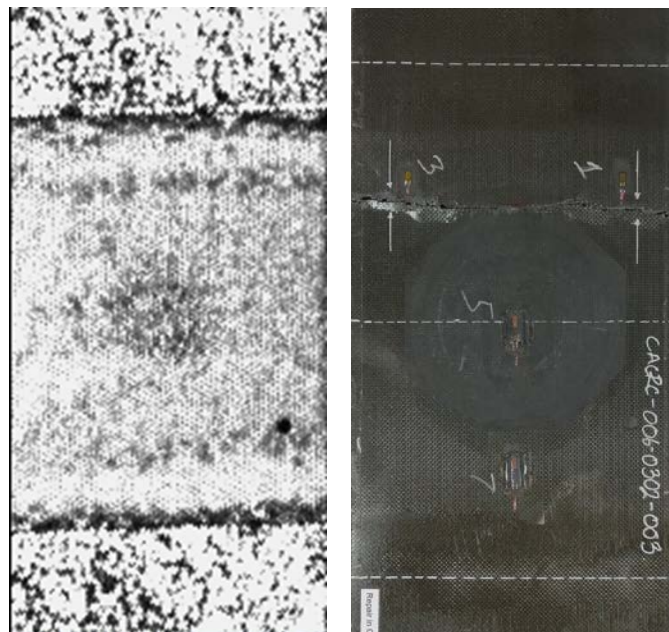
Figure 73. CACRC-006-0302-003-W-RC-ETW (element 27), TTU scan, pre- and post-test picture (facesheet compression failure through the repair)
